Case Study – Guano & Mould Cleaning

Removing guano and mould from a residential property.

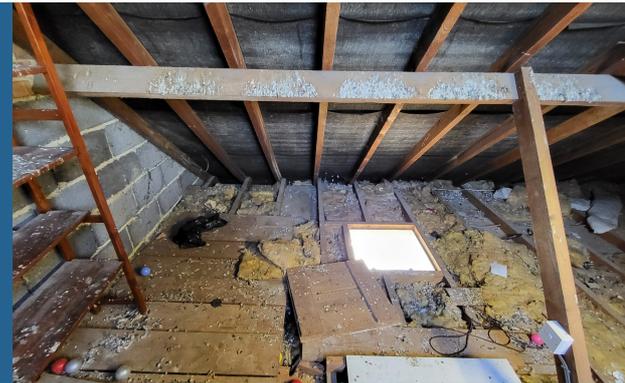
Client's Problem: Contaminated loft space after pigeons entered the roof space via a hole in the roof, water ingress from rain.

A client got in touch with Vinci Response Services after discovering that birds had got into her attic through a hole in her roof and had left guano and feathers all over the loft. There was also mould throughout the attic which also needed cleaning.

Vinci's experienced team cleared and cleaned the loft space before undertaking guano decontamination and mould remediation. Loft insulation and other contaminated items also had to be removed and safely disposed of.
