Case Study – Brick Paint Removal & Restoration

Paint Removal From Residential Property

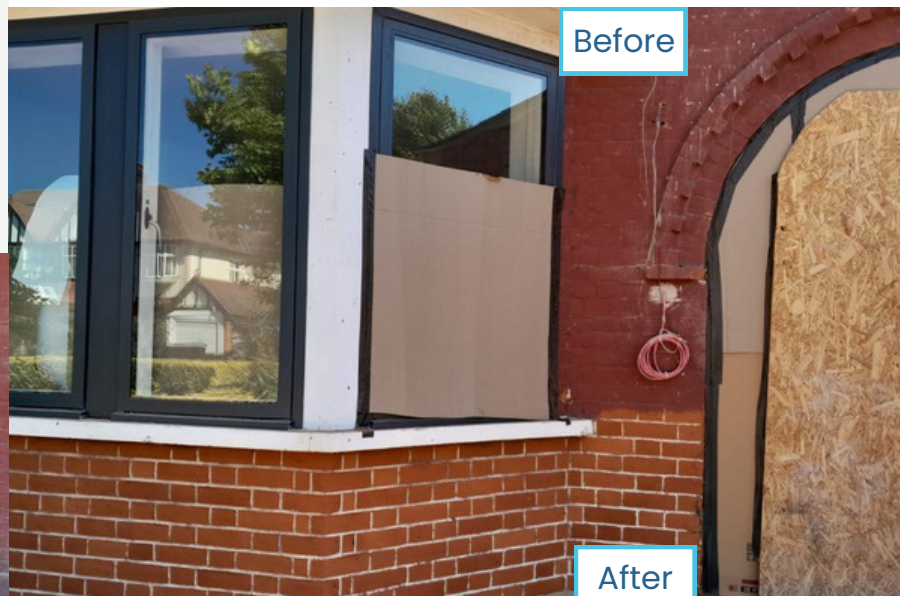
Client's Problem: The home owner contacted Vinci Response to discuss the removal of red brick paint from the outside of their property. They wanted the original aesthetic and visual appeal restored.

- ✓ **Pre-Remediation**
Before the remediation began, some important safety and preparation work was needed. Notably, ground and window protection was put in place to ensure the removal and restoration process did not damage the property.
- ✓ **Remediation**
All surfaces covered in red paint were blasted with the 1028NC Blast Pot. This is an excellent tool that can blast surfaces without causing damage to the original structure. It is very effective at removing paint, corrosion, and graffiti.
- ✓ **Post-Remediation**
Following blasting, the bricks and mortar were checked, the ground and window protection was removed, the site was thoroughly cleaned, and the job was complete.
