Case Study - Fire Damage

Fire Decontamination after an Explosion in a Warehouse Unit

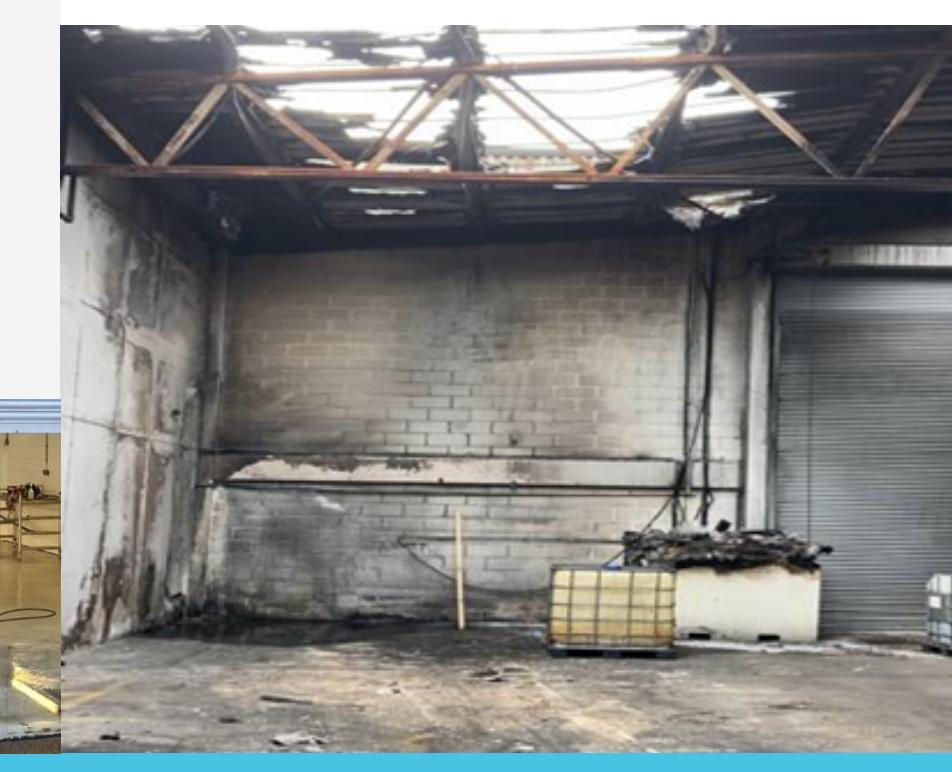
As the fire started in the coach store it was the worst affected area with heavy soot deposition afforded to the structure and machinery. However, the other areas still needed cleaning and to be checked for signs of hidden damage.

The area is the cleaned from top to bottom. Difficult to reach places are reached using boom lifts and scaffold towers. A large floor scrubber is required to clean the floor areas which were blackened with smoke.

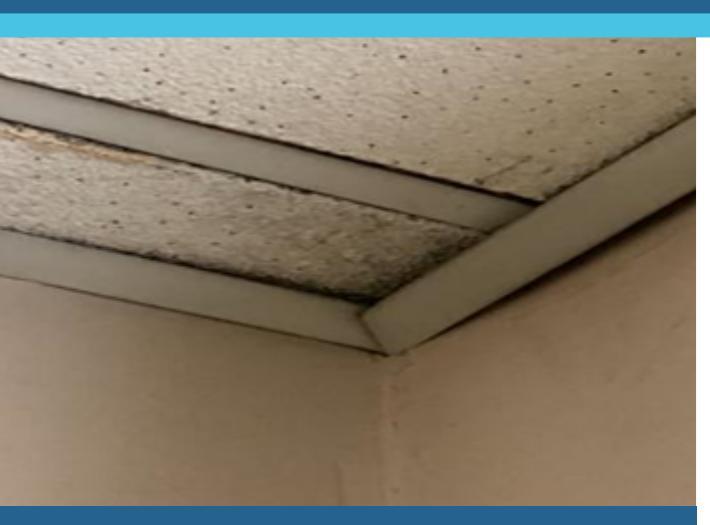
The corners of rooms are often tell-tale signs of hidden damage caused from smoke and the burning of plastics.
